Official Accident Report Index Page

GROUND SPOILER ACTIVATION IN FLIGHT/HARD
LANDING VALUJET AIRLINES FLIGHT 558
DOUGLAS DC-9-32, N922VV NASHVILLE,
TENNESSEE JANUARY 7, 1996

Weather conditions	Ice, snow
Total crew size	5
Cockpit crew size	2
Cabin crew size	3
Passengers	88
Report ID	NTSB/AAR-96-07
Pages	174
Day or night?	Day
Flight number	558
Flight origin	Atlanta, GA

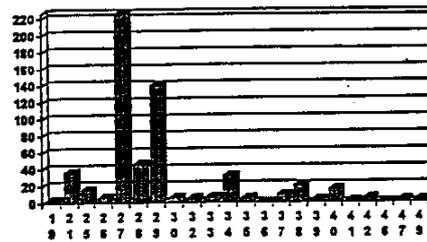
PTRS DATA FOR FY 94 & 95

The histogram clearly shows that the most accomplished inspection is the ramp inspection PTRS Code 3627 and the least accomplished is the structural inspection PTRS Code 3646.
